TS-PIC-9809925S/9909925S
December 1998

AERIAL PHOTOGRAPHIC ANALYSIS WASTE DISPOSAL, INC., SITE Santa Fe Springs, California Report 1 - Hazardous Waste Site Characterization, Main Site

D. R. Williams
Environmental Services Division
Lockheed Environmental Systems & Technologies Co.
Las Vegas, Nevada 89119

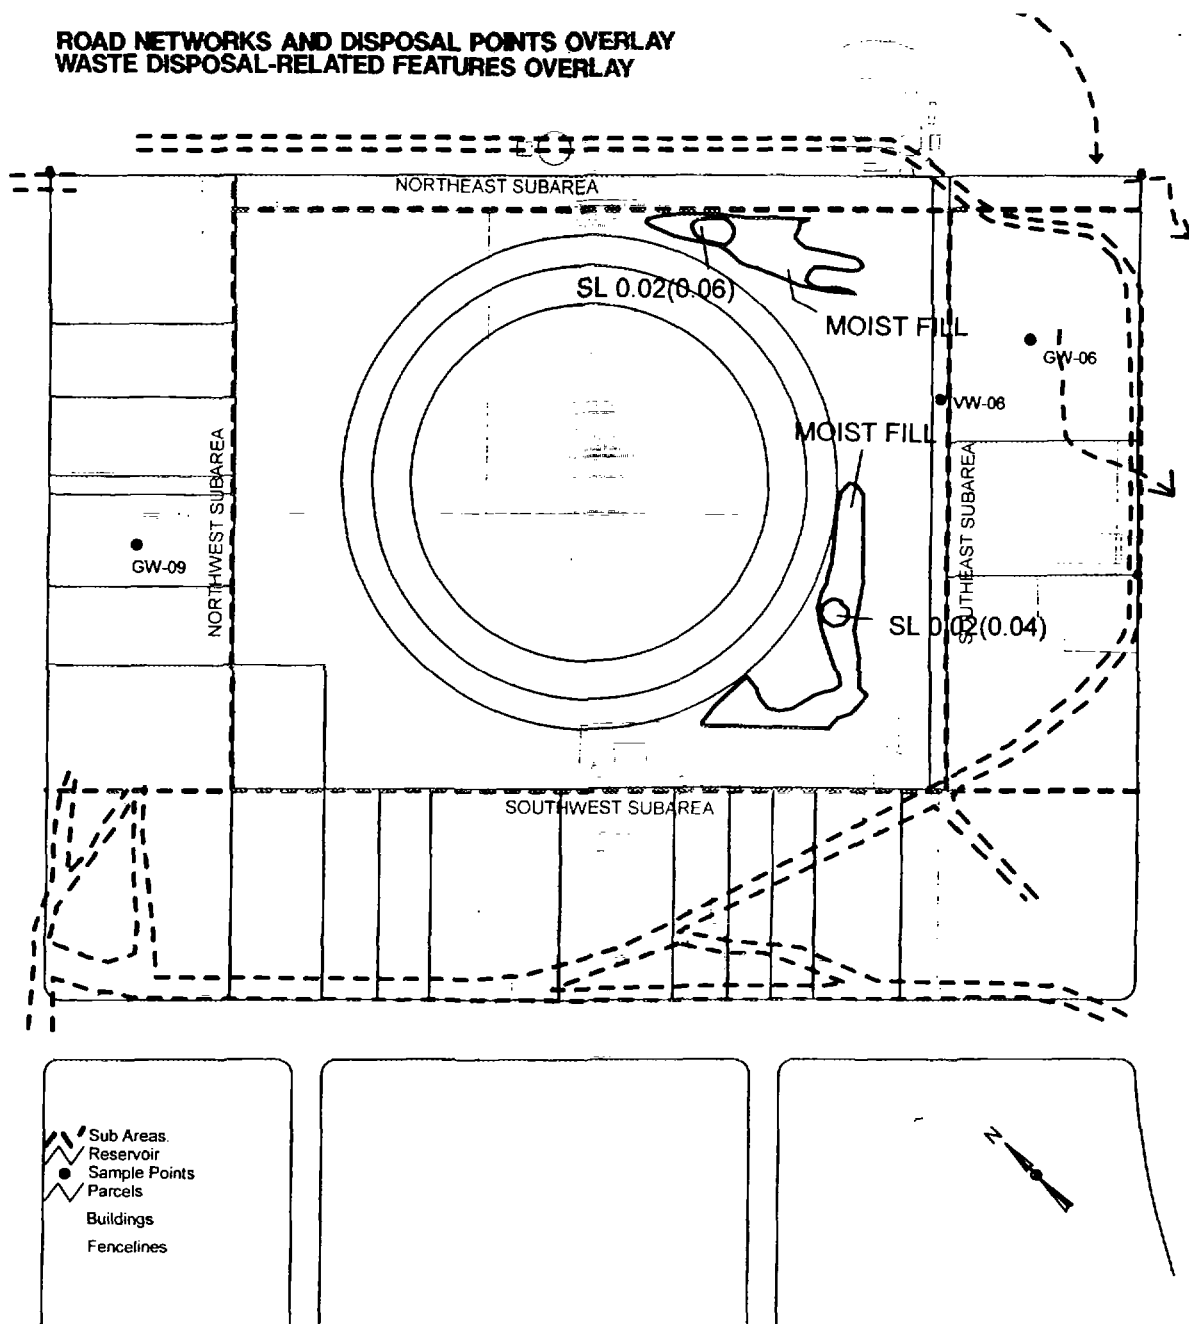
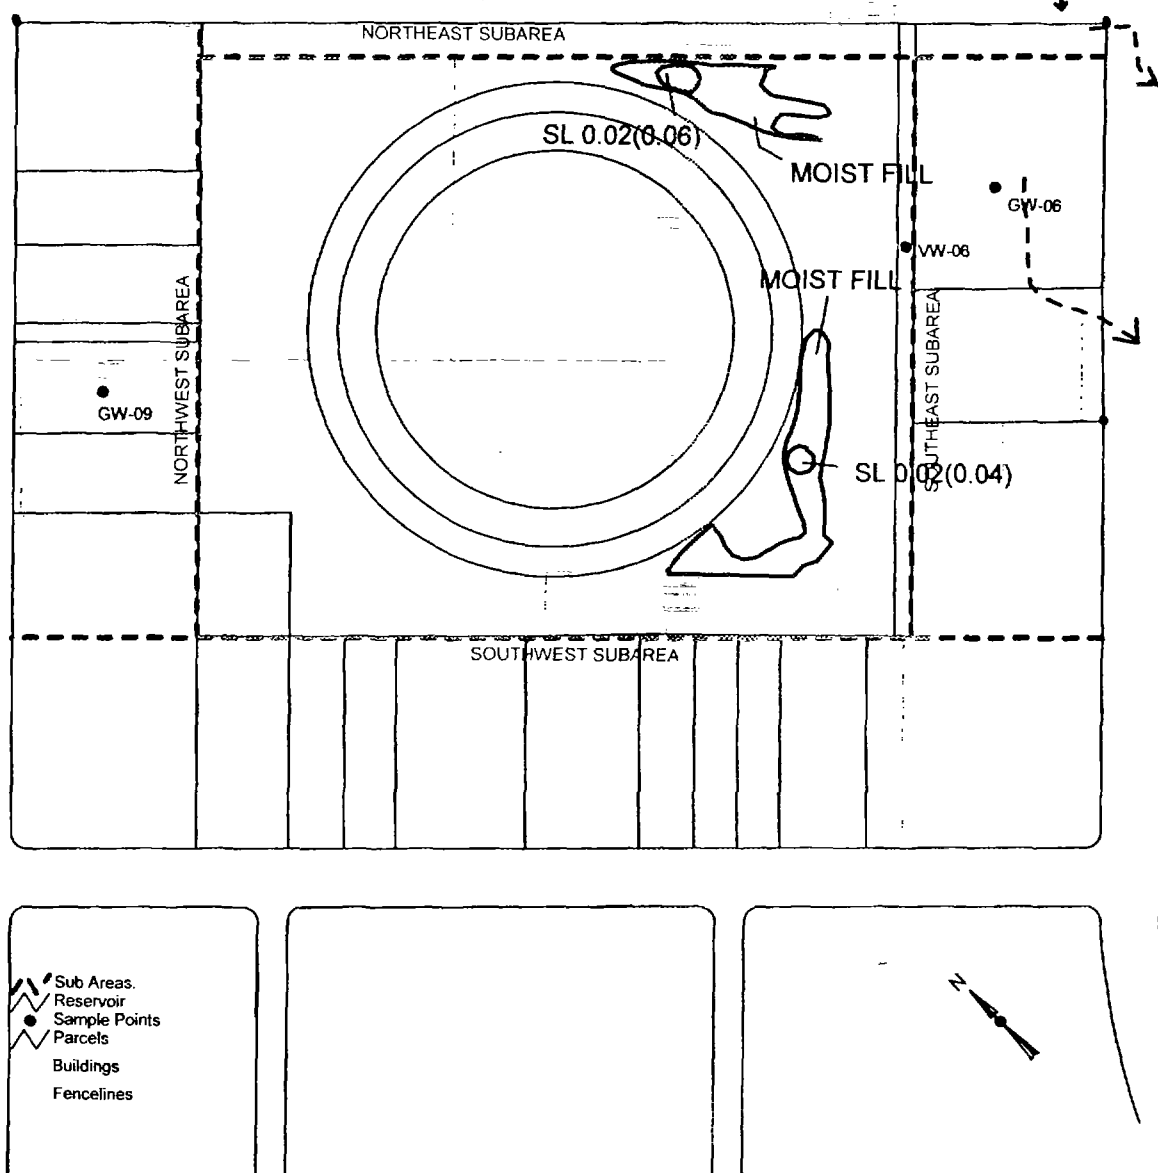
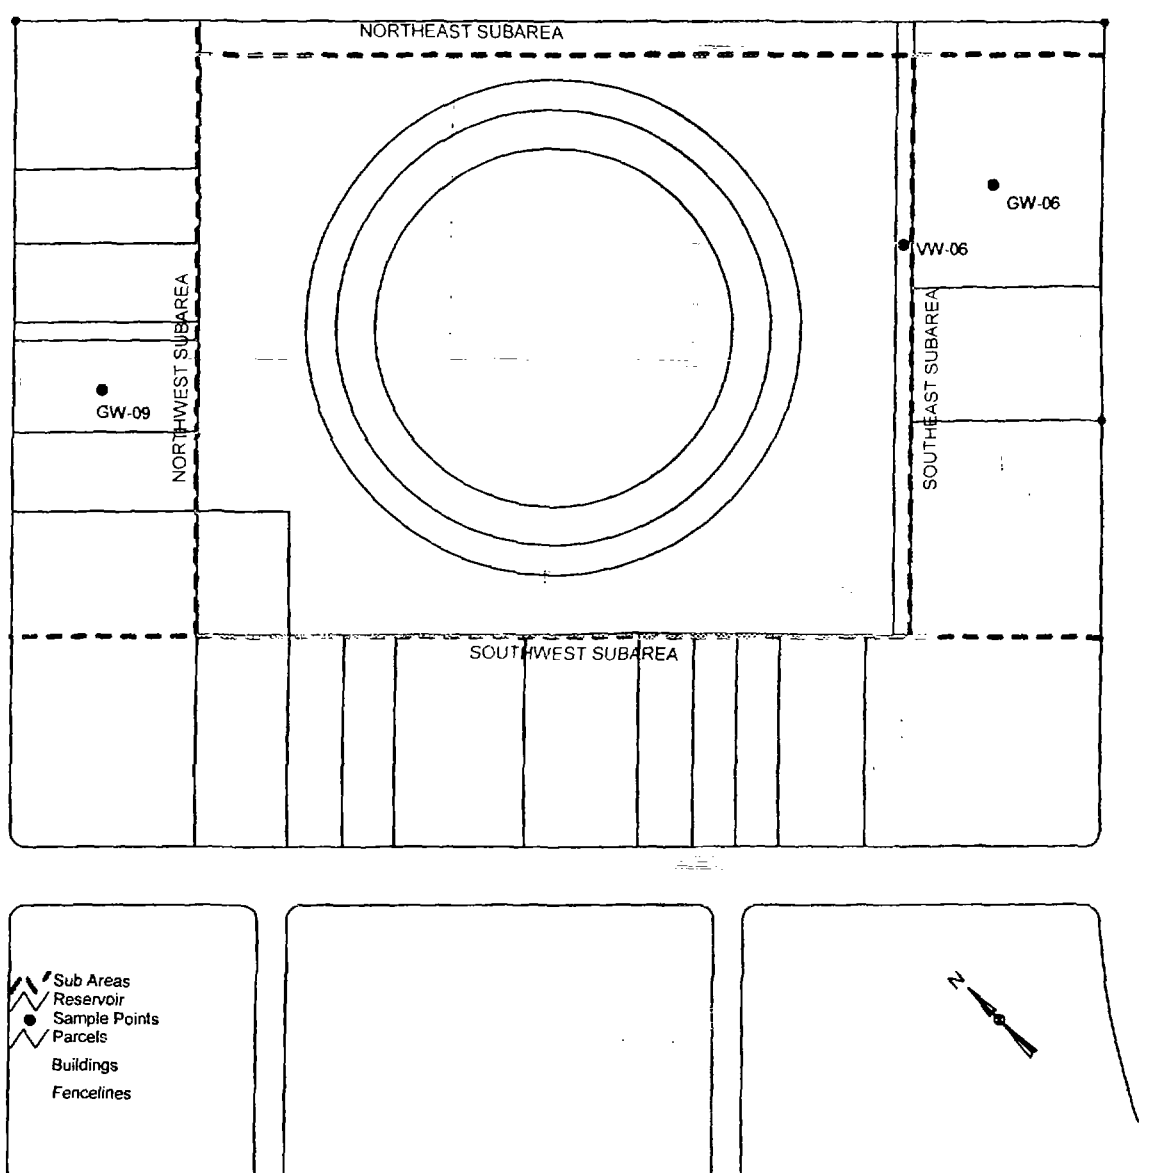
Figure 3. Waste Disposal, Inc., Site map, 1927. Approximate scale 1:3,850.

An oblique aerial photograph (see references) in June of 1923 shows that construction of the oil reservoir is apparently complete. In 1927 no significant features are observed within the reservoir.

In 1927, standing liquid (SL) and moist fill are present within the Earthen-Diked Subarea outside of the reservoir.

By 1927 a site road network had been established around the Earthen-Diked Subarea. Access roads lead onto the southern, western, and northern sections of the site.

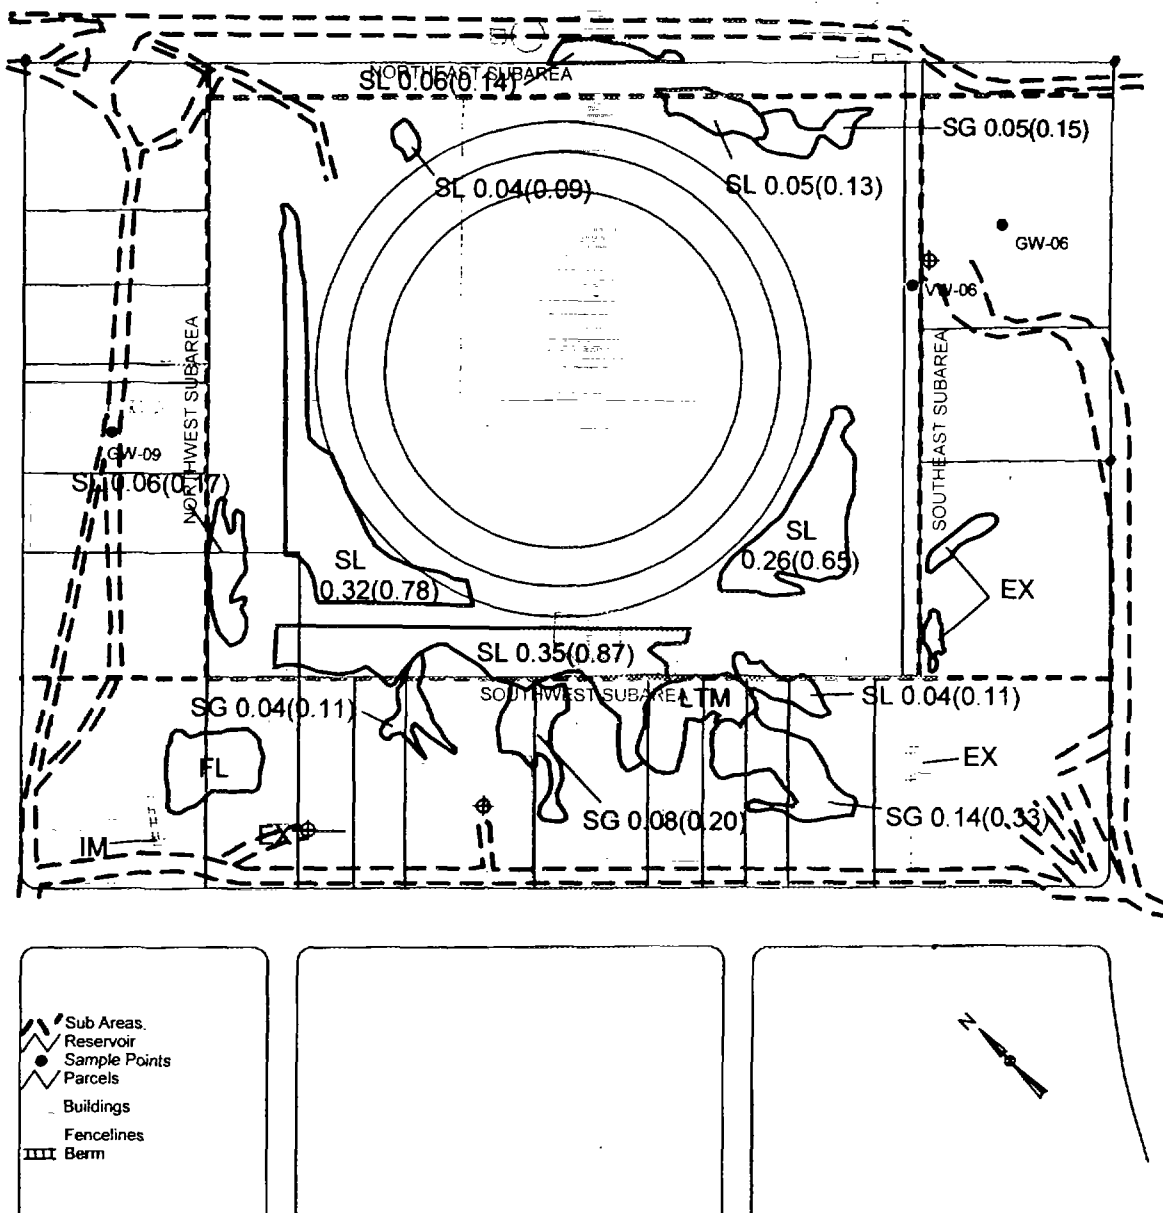
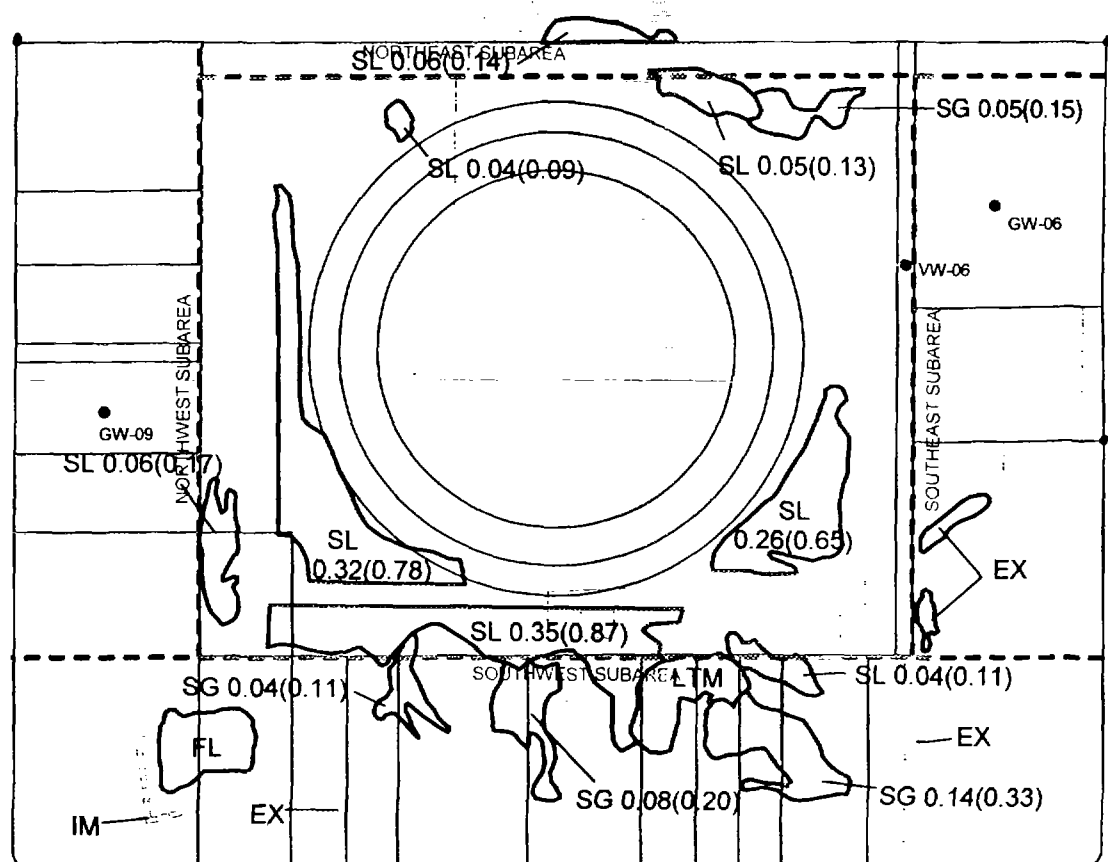
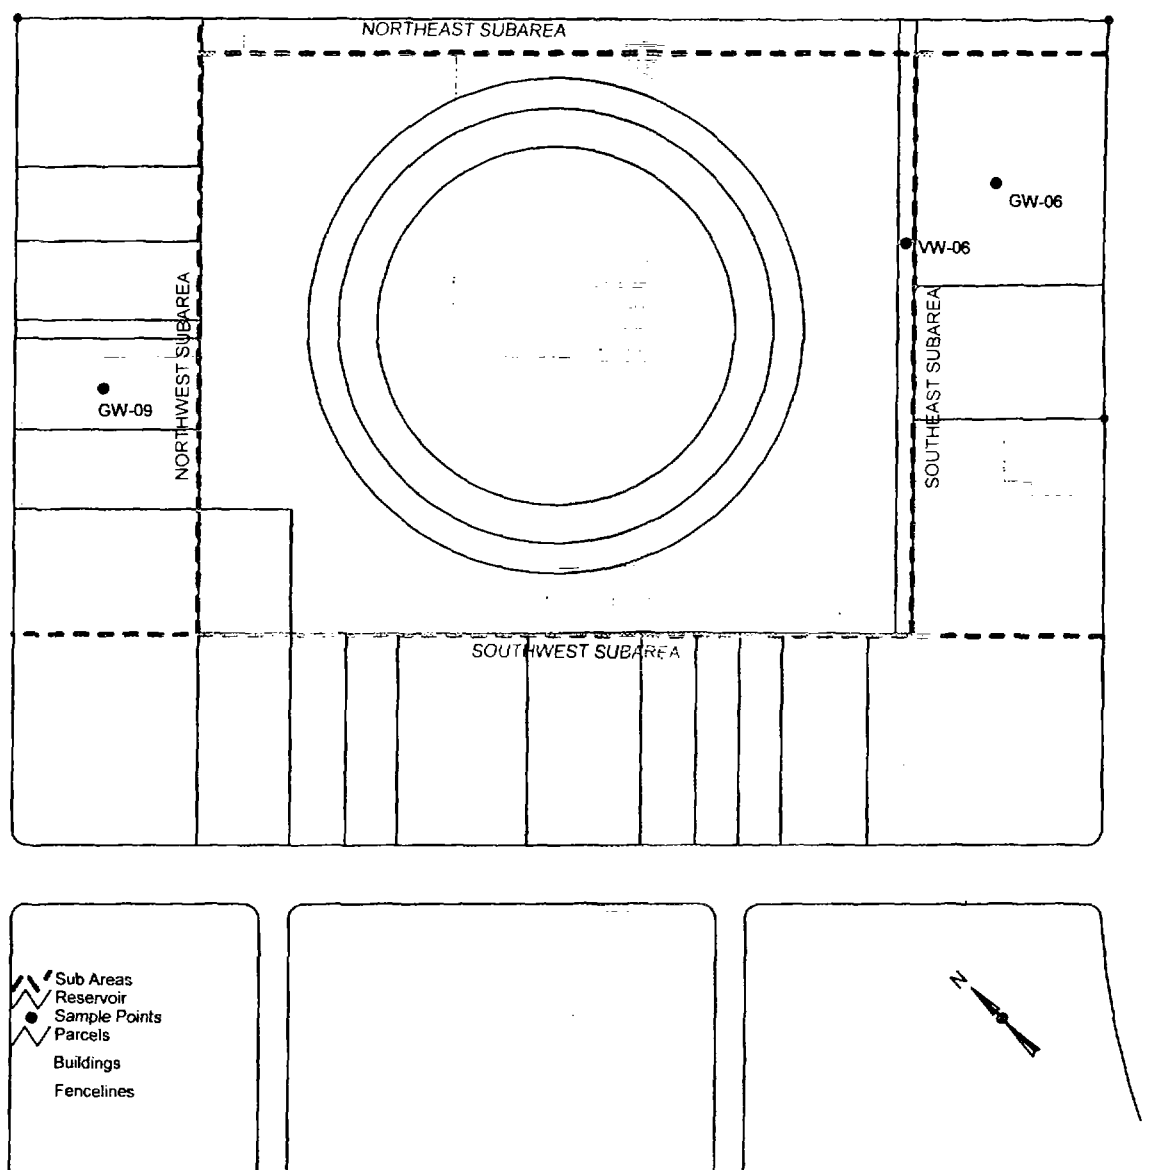
Figure 4. Waste Disposal, Inc., site map, 1928 Approximate scale 1:3,850.

Sun glint (SG), caused by direct reflection of the sun from very shallow areas of standing liquid, is visible within the subarea. Four areas of standing liquid are also noted.

Two small excavations are present in the Southeast Subarea. In the Southwest Subarea a large area of standing liquid is seen adjacent to the earthen dike and sun glint is seen to the south and southwest. Judging from the orientation of the sun glint areas, liquid wastes have been deposited near Los Nietos Road and have probably flowed into the large area of standing liquid. A revegetated impoundment and a small pit are observed in the western corner of the site.

An extensive road network with three waste disposal points has been established since 1927. Liquid wastes have probably been deposited at the disposal point in the Southeast Subarea. Two additional waste disposal points are seen in the Southwest Subarea. The site is accessed at the north and south corners and along the southwestern site perimeter.

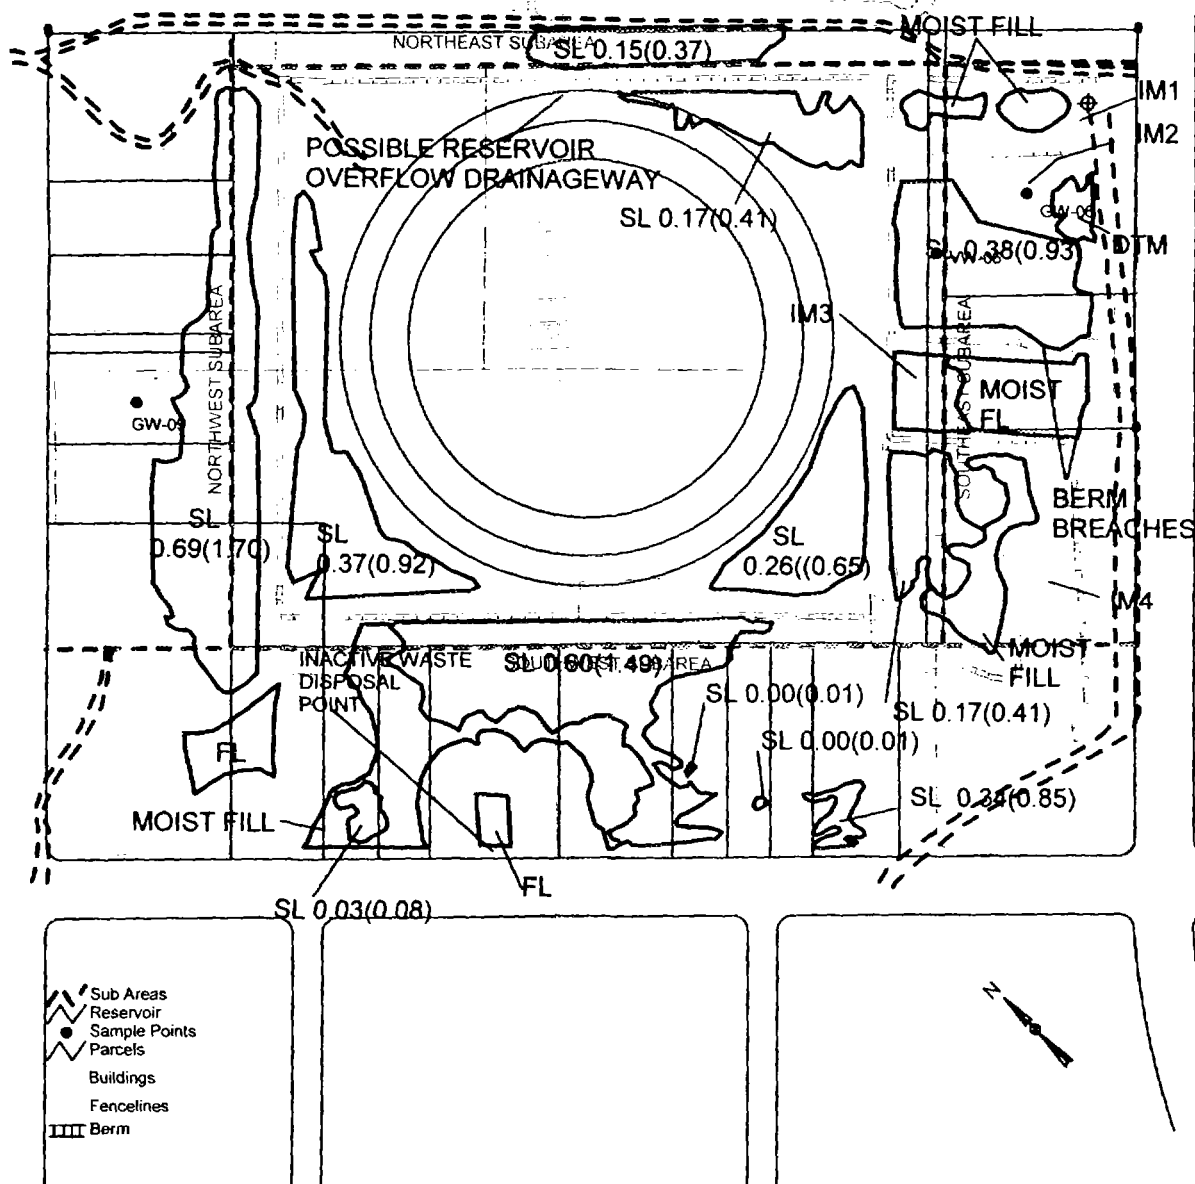
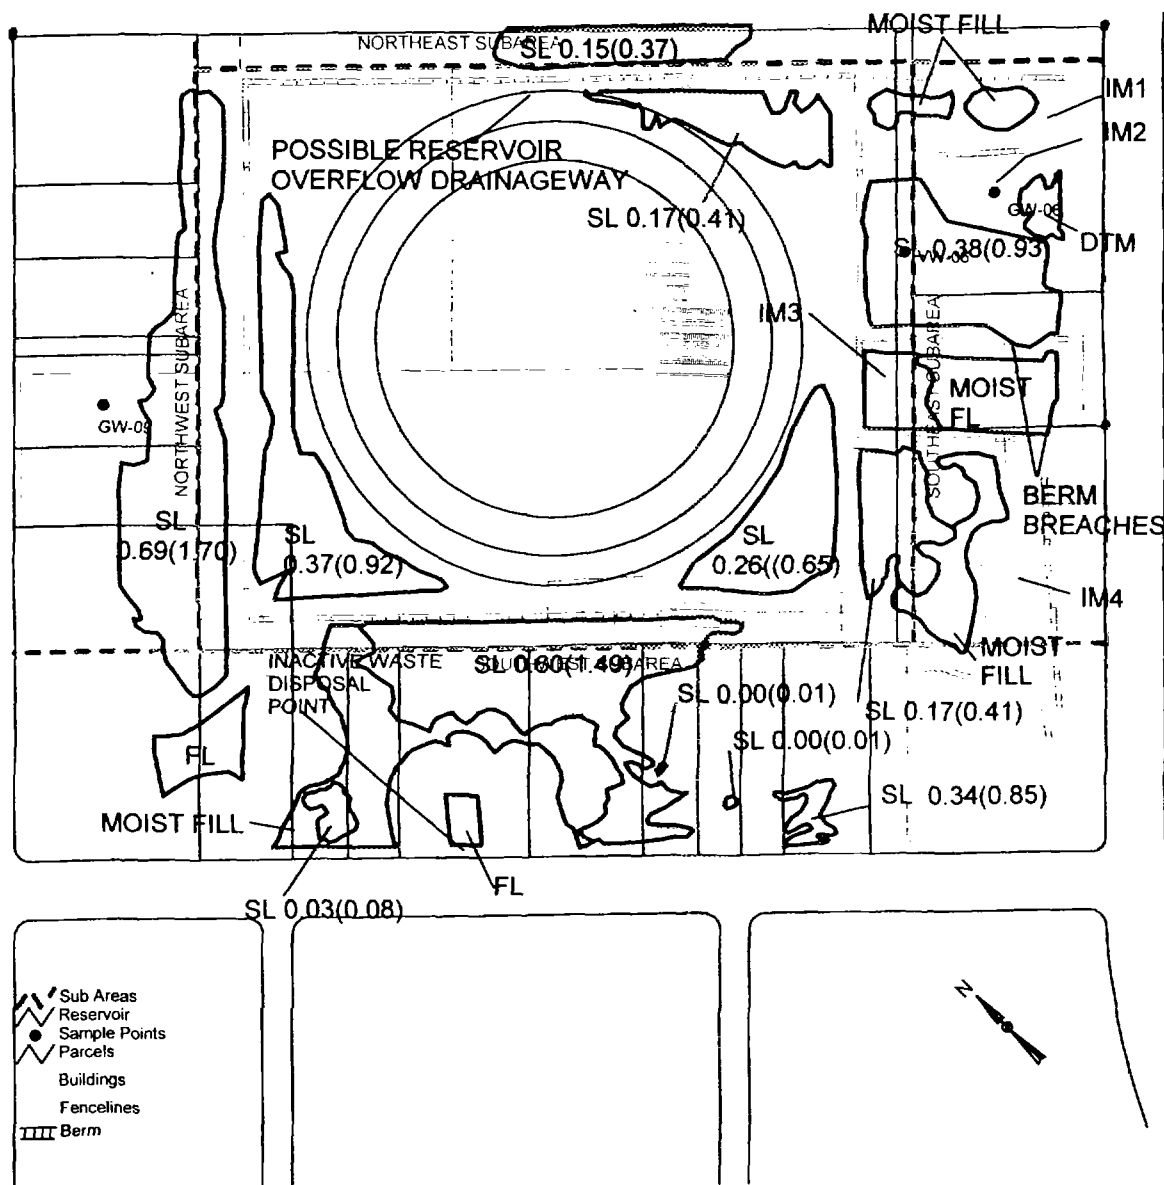
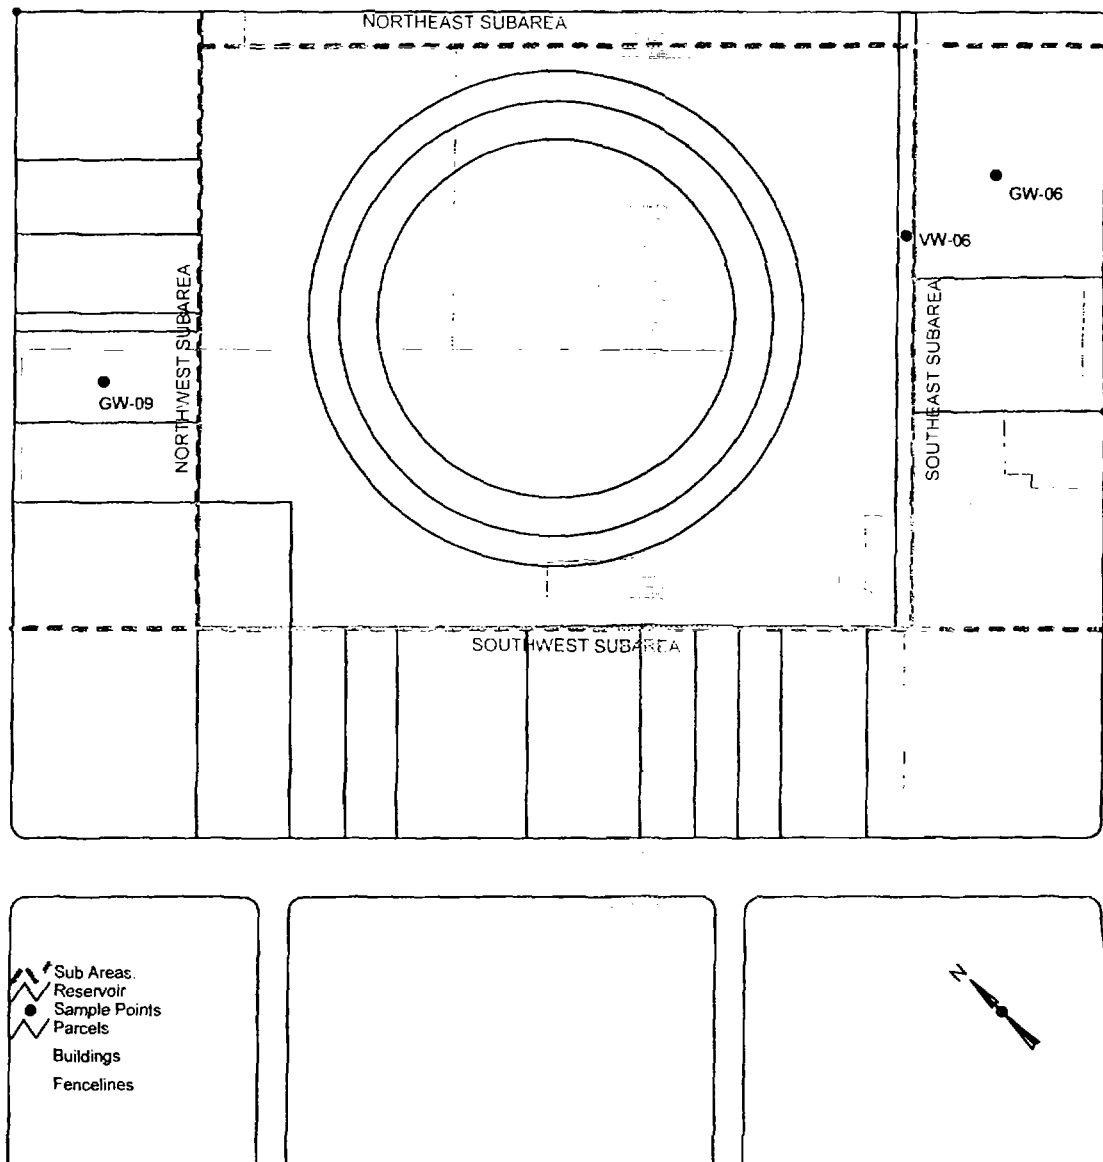
Figure 5. Waste Disposal, Inc., site map, February 20, 1937. Approximate scale 1:3,850.

The oil reservoir is covered and no assessment of the contents is possible. A small channel is observed adjacent to the reservoir indicating the presence of a possible overflow drainageway into the Northeast Subarea of the site.

Standing liquid is seen in the same general locations as observed in 1928. Standing liquid is now present in three of the four corners of this subarea.

A series of four impoundments has been constructed in this subarea since 1933. An oblique aerial photograph taken in 1933 (see References) shows that no impoundments had been constructed at that time. In 1937, Impoundment 1 contains fill material and moist fill. A large area of turbid standing liquid is present in Impoundment 2 and dark-toned material (DTM) is seen nearby. Impoundment 3 also contains moist fill and surface drainage flows in a southeasterly direction atop the fill. A breach is present in the berm of Impoundment 2. Liquid materials have migrated from a similar breach in Impoundment 3 into a ditch along the adjacent access road. Impoundment 4 contains moist fill and standing liquid.

Only one disposal point located near the eastern corner of the site was identified in 1937. The site is accessed from the northern, southern, and western corners.

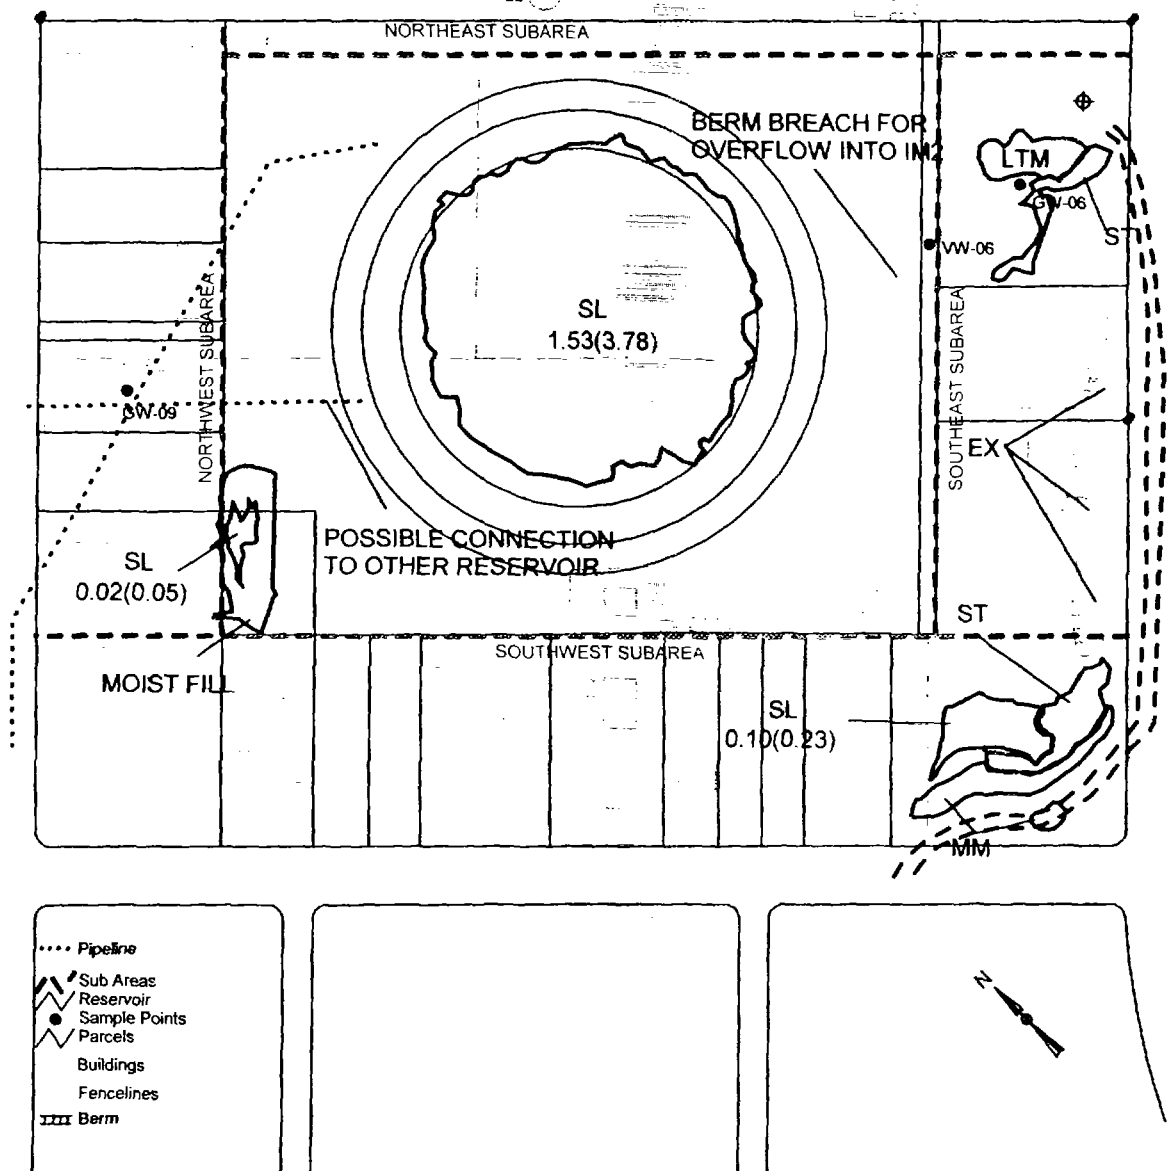
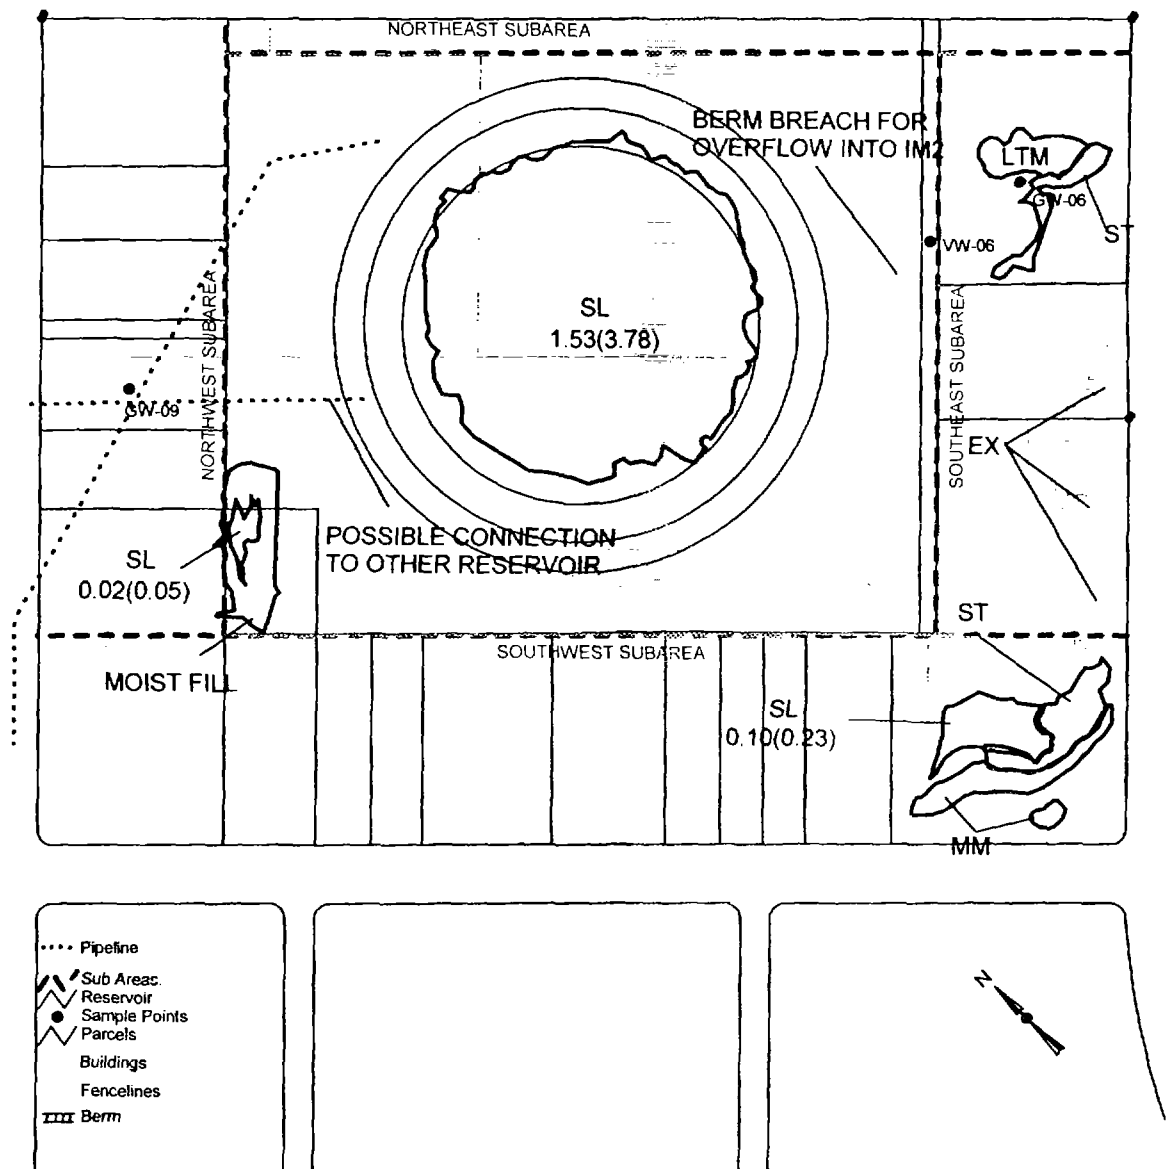
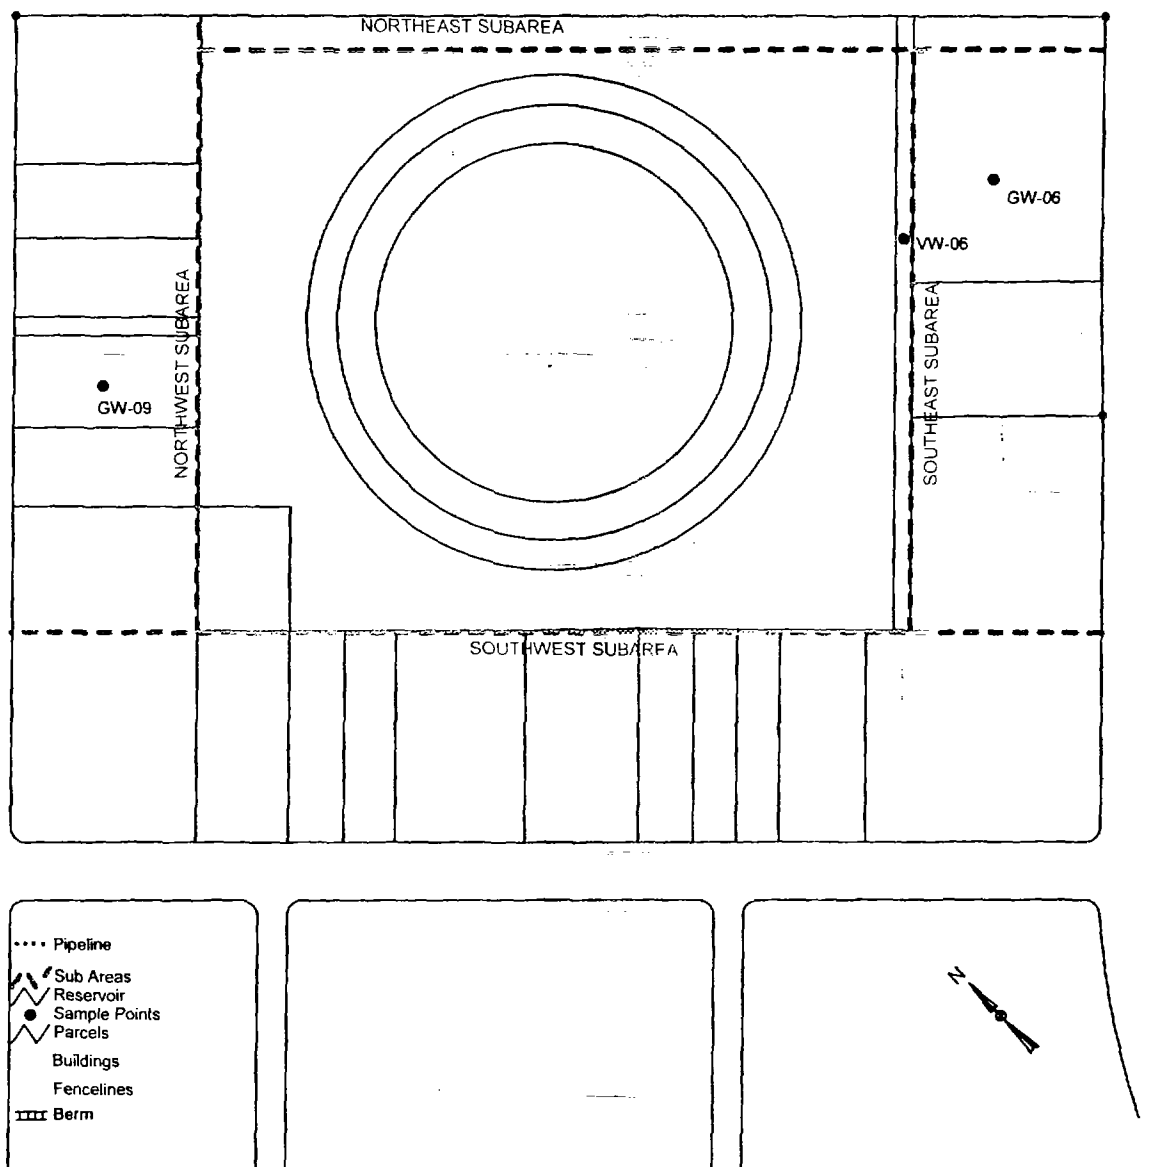
Figure 6. Waste Disposal, Inc., site map, January 1, 1945. Approximate scale 1:3,850.

Standing liquid is present in the reservoir. A possible connection (pipeline) to another similar reservoir to the northwest is also noted.

Impoundment 1 is completely covered with vegetation. A relatively recent deposition of light-toned material and a large stained area are visible in Impoundment 2. A berm has been breached at the northwestern side of Impoundment 2 that allows for a possible overflow of liquid from the Earthen-Diked Subarea to the impoundment. Impoundments 3 and 4 are inactive and covered with vegetation; however, the southeastern end of both impoundments has been partially excavated. A dark-stained area is seen next to the standing liquid present at the southern corner of the site. The dark-stained area appears to be a spillway where liquids are off-loaded from tankers. Since the staining within the spillway is dark-toned, the standing liquid is probably also dark-toned.

The entire area is partially covered with vegetation and is inactive. Moist fill is visible adjacent to the western corner of the Earthen-Diked Subarea.

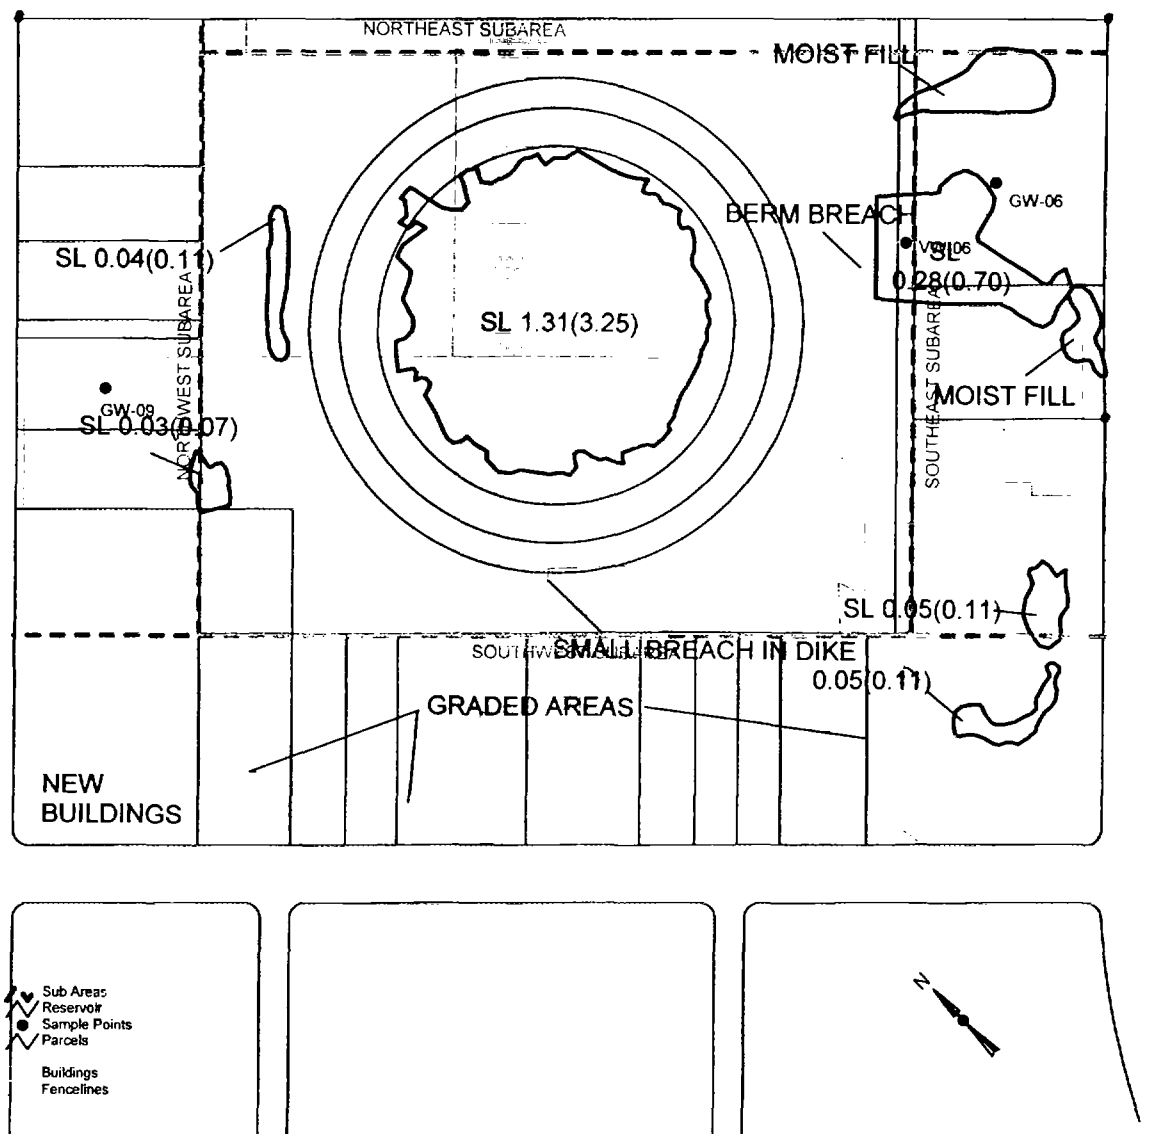
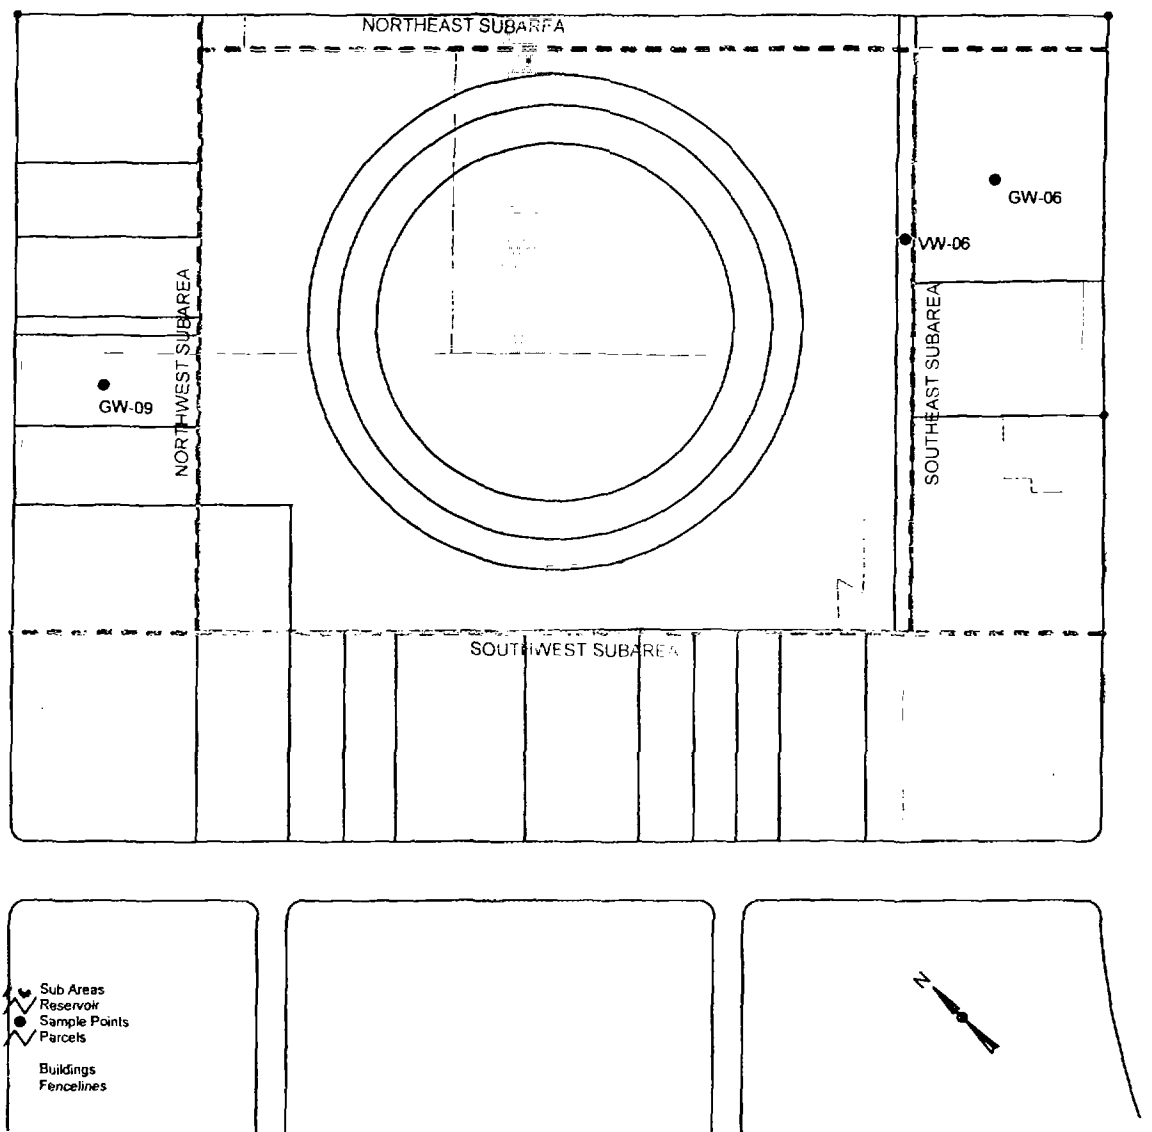
Figure 7. Waste Disposal, Inc., site map, February 16, 1949. Approximate scale 1:3,850.

Moist fill is observed in Impoundment 1 and standing liquid is seen in Impoundment 2. Moist fill is present southeast of Impoundment 2 indicating a probable flow of liquids from the impoundment. To the southwest are two additional areas of standing liquid. Several new buildings are present in the western corner of the site. Three large areas of land have been graded, possibly in preparation for additional construction at the site.

One area of standing liquid is present next to the earthen dike.
